Keramikbruch extrem selten

The end of the taper disaster

Michael M. Morlock

Institute of Biomechanics
TUHH Hamburg University of Technology

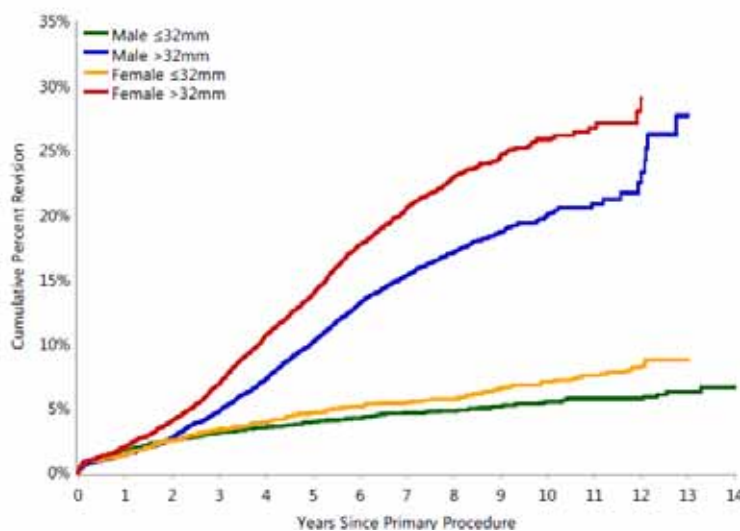
Figure MM6 Cumulative Percent Revision of Metal/Metal Primary Total Conventional Hip Replacement by Gender and Head Size (Primary Diagnosis OA)

HR - adjusted for age

Male ≤32mm vs Male >32mm

0 - 1.5Yr: HR=1.06 (0.80, 1.40), p=0.702

1.5Yr - 3Yr: HR=0.33 (0.22, 0.50), p<0.001

3Yr+: HR=0.14 (0.11, 0.19), p<0.001

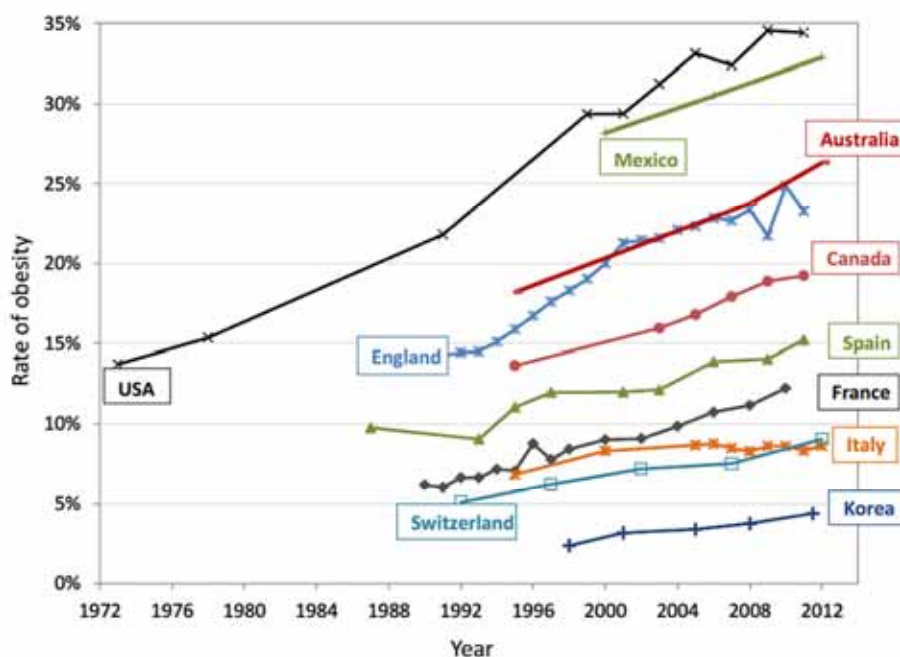
Figure 2. Obesity rates

Note: Age- and gender-adjusted rates of obesity and overweight, 2005 OECD standard population. Measured height and weight in Australia, England, Korea, Mexico and the United States; self-reported in other countries. Source: OECD analysis of health survey data.

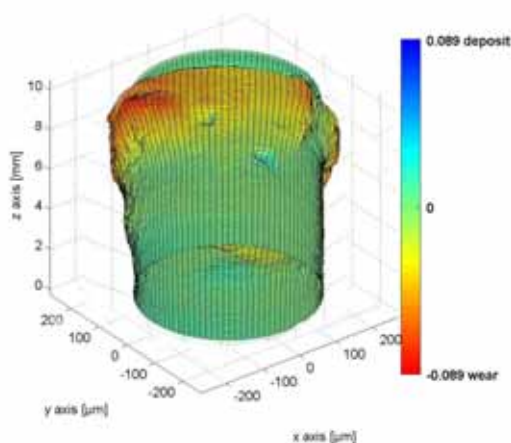
Movement / separation at the taper interface is a prerequisite for the start of mechanically induced tribocorrosion (fretting).

Residuals [mm] of selection 70% of Data Points

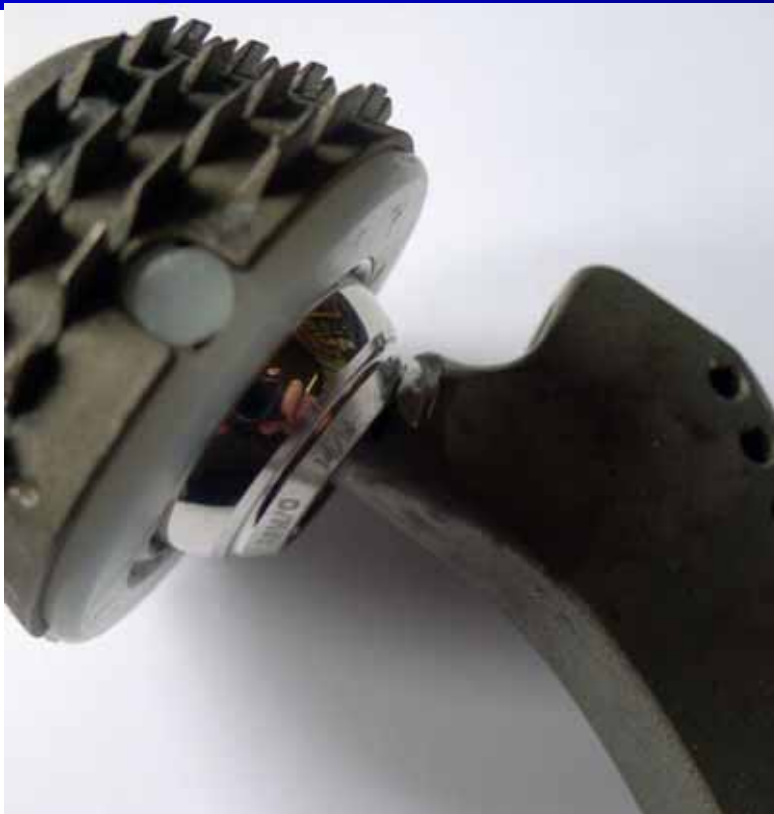
Major mismatch

76 y female
16 years in situ

Little biological
reactions since
little Co or Cr

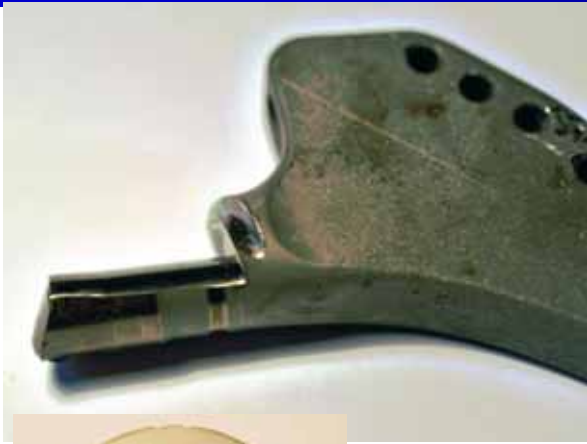
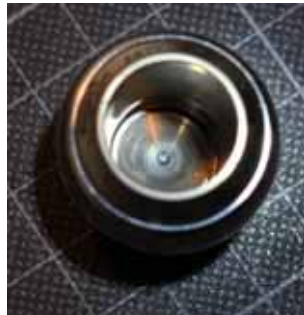
Major mismatch

76 y female
16 years in situ

Little biological
reactions since
little Co or Cr

14/16 head
on a
12/14 taper

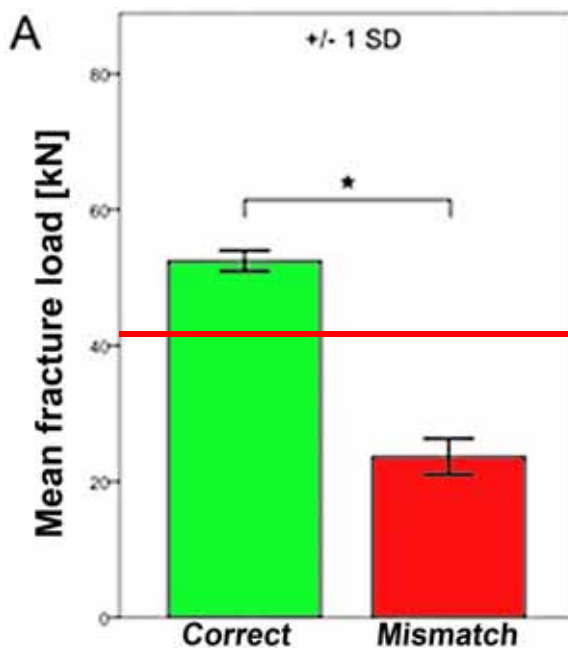
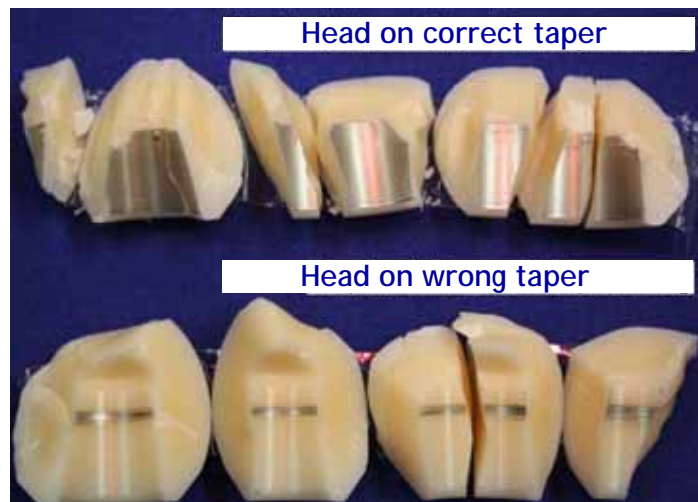
Major mismatch

“Type I” instead of V40 taper, (Gührs et al, 2015 in press)

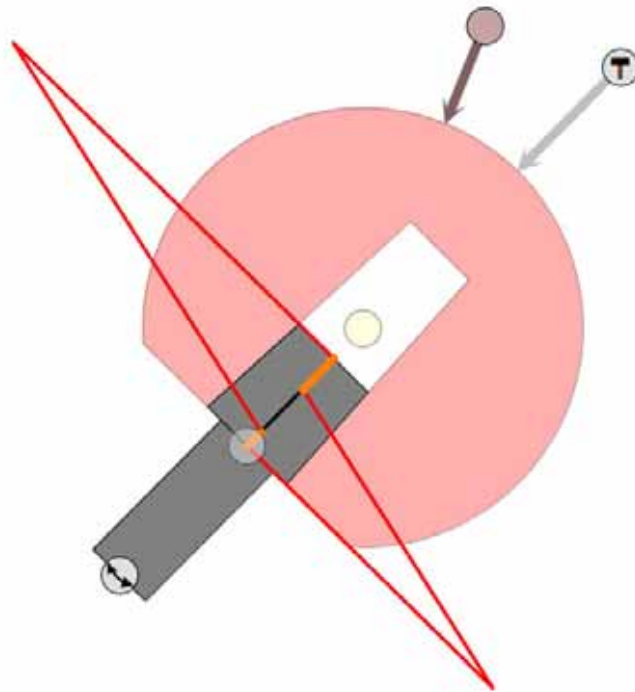
Taper interface loading

Geometry	
head diameter	36 mm
taper angle	5,725 °
stem taper diameter (proximal)	16 mm
neck angle	45 °

Forces	
impact force	4000 N
joint force	2900 N

Legend	
●	radial stresses
●	separation (between head and stem)

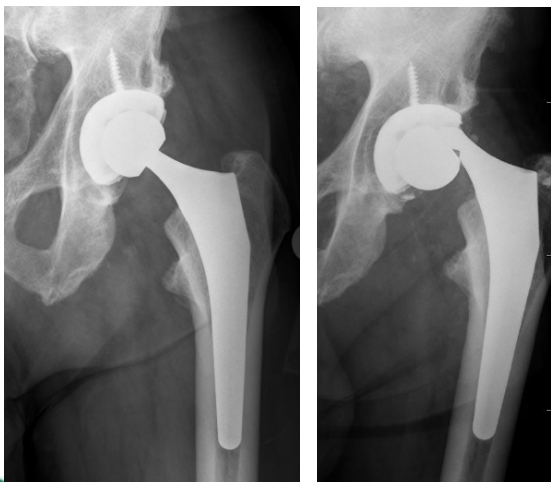
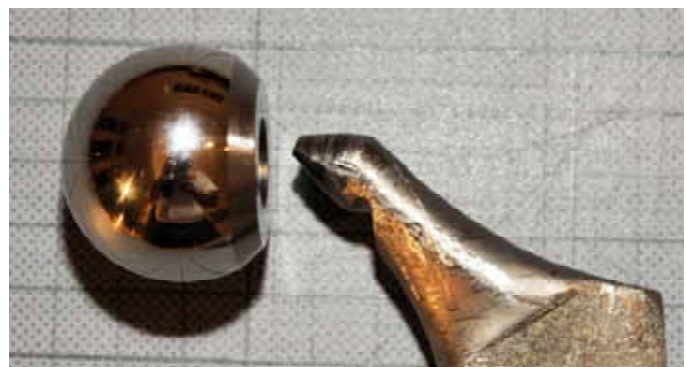
Example - what caused it (n=4)

- Soft Ti?
- Small Taper?
- Large Head (36mm is large!)?
- Contamination? Assembly?
- High loading?
